Bus Initiatives Issue 4: Bus Stop Infrastructure Review

SEStran July 08

2.2 Bus Shelter Condition

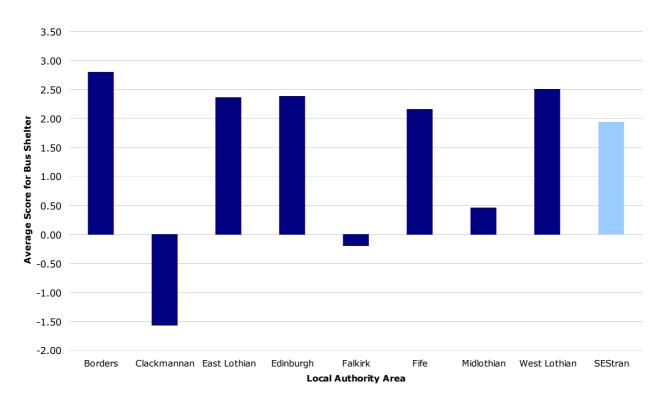
Figure A: Average Score for Bus Shelter by Local Authority Area

- 2.2.1 Table 1 below shows our assessment of bus shelter condition, with the average score by local authority shown in Figure A. Of the 240 bus shelters visited as part of the surveys, 72% were in very good condition but these were not evenly distributed. 33% of these shelters were in Edinburgh and 24% in Fife, a very positive outcome for these two authorities. Just over 11% of shelters in the SEStran area were in reasonable condition giving a positive score for 83% of shelters.

- 2.2.2 22 of shelters in the observed were categorised as badly vandalised and sixteen more bus shelters were noted as having some vandalism or being in poor repair. Falkirk had the highest percentage of poor or badly vandalised shelters at (10 out of 15).

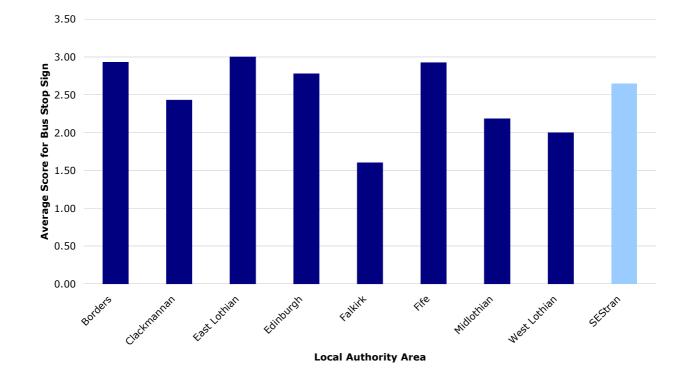
Figure B: Average Score for Bus Stop Sign by Local Authority Area

2.3.1 Table 2 shows the assessment of bus stop signs by local authority area. Only eleven stops out of 240 surveyed were found to be showing evidence of wear

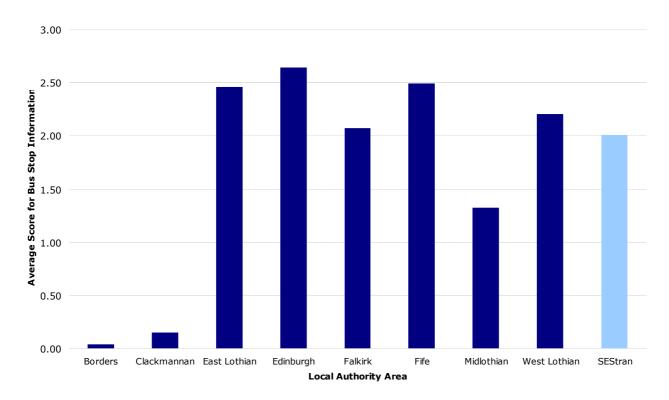
Figure C: Average Score for Bus Stop Information by Local Authority Area

- 2.4.1 Of the bus stop information provision surveyed, Table 3 shows that 21 stops had no information at all, thus these stops fail to comply with the Transport (Scotland) Act 2001 definitions of 'local bus information' as shown in Section 3.3. 13 of these were in the Scottish Borders Council area, with further examples in each of Clackmannanshire, Edinburgh, Falkirk and Fife. Of the stops with out of date information, these accounted for just over 4% of the stops visited. Only two of stops in the area which were visited contained information that was up to date but in poor condition.

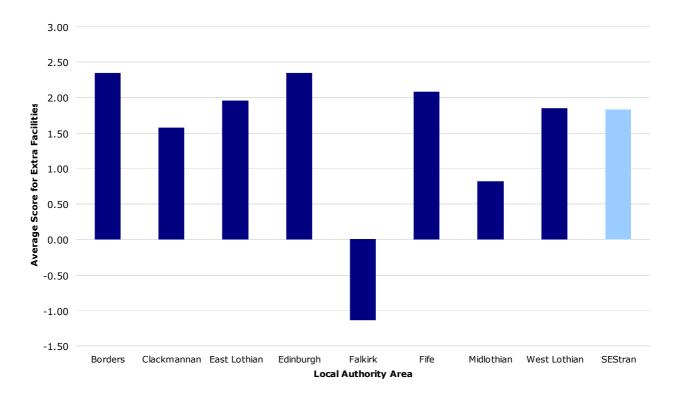
Figure D: Average Score for Extra Facilities by Local Authority Area

2.5.1 Table 4 below shows that within the SEStran area, 66% of bus stops surveyed have seating, lighting and a raised kerb, with high percentages in four local authority areas. Almost 15% of other stops had lighting or seating, or a raised kerb, while just under 8% of stops had no additional facilities, including 60% of stops in Falkirk. In Figure D below, Edinburgh and the Borders have the highest average scores for extra facilities, while Falkirk has a negative average score, reflecting the poor condition of some of the bus shelters in the area, some of which require replacement.

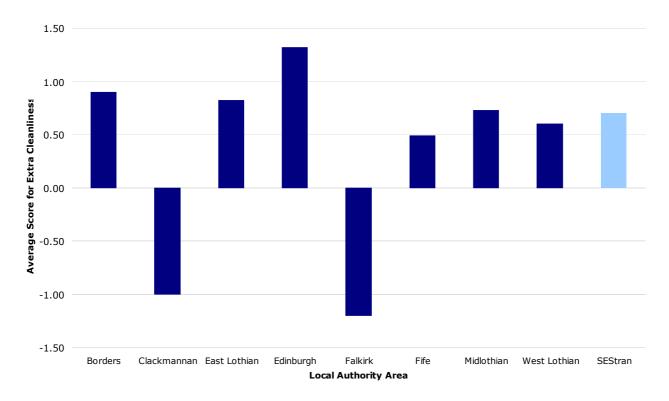
Figure E: Average Score for Cleanliness by Local Authority Area

- 2.6.1 In terms of bus stop cleanliness, Table 5 demonstrates that 17 (just over 7%) bus stops surveyed were given a score of -3 (dirty with evidence of litter and dirty glazing). 62 (26%) of stops had evidence of short term dirt. This category took account of stops that were considered by the observers to be dirtier than was reasonable, but not in such a condition that they should have received a worse score.

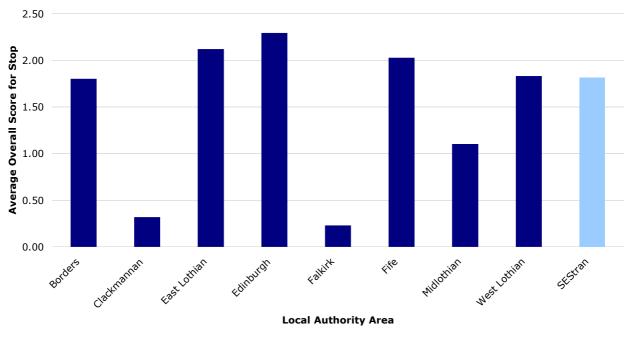
Figure F: Overall Average Score by Local Authority Area

2.7.1 From the categories above we calculated an average quality score for bus stop provision. The results are presented by category in Table 6 and Figure F. As can be seen from Figure F, Edinburgh has the highest average scoring across all categories, with East Lothian and then Fife second and third highest. Falkirk has the lowest scoring, with Clackmannan second lowest.

- 2.7.6 Figure F above shows overall average scores by Local Authority Area, with Edinburgh having the highest average score, followed by East Lothian, Fife, Borders and West Lothian. Midlothian has an average score of 1 on the journeys surveyed, while Falkirk and Clackmannanshire have low average scores, related to condition and cleanliness of infrastructure as already mentioned.

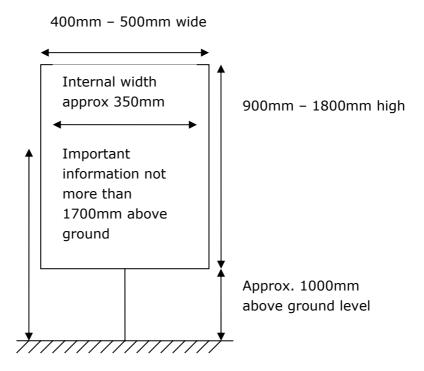
Figure I: Ideal Dimensions of a Bus Stop Information Panel

- 3.4.5 The ideal dimensions of a bus stop information panel, as recommended by the DfT^5 , are shown in Figure I below. In addition, the panels should be well lit and kept out of the rain if at all possible.

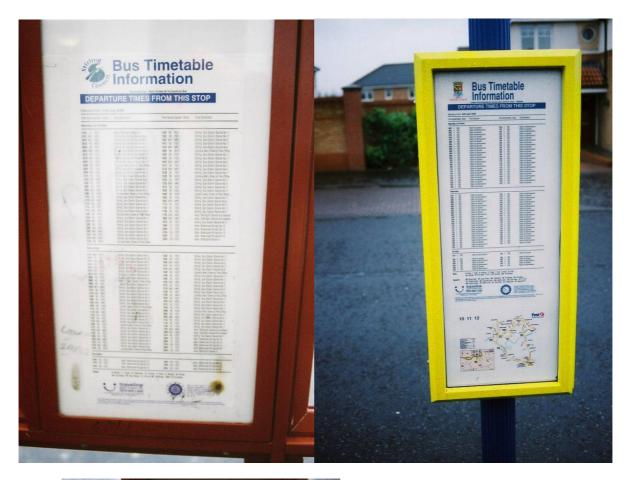
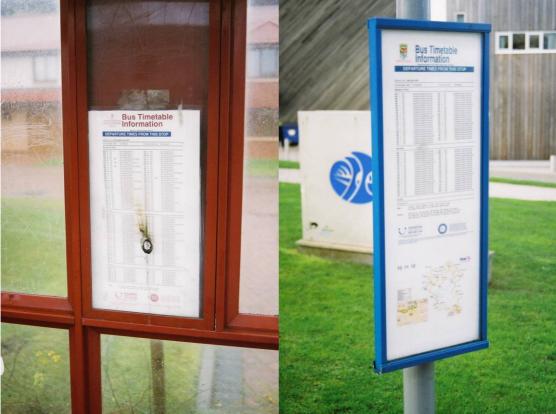
Figure J: Examples of Clackmannanshire, Falkirk and Stirling Standard Timetable Presentation

- 3.8.1 This section contains an illustrated review of some of the types and styles of information provision found across the SEStran area. Clackmannanshire, Falkirk and Stirling all use the same basic format of information provision inherited from the former Central Region. Figure J below shows examples from Clackmannan Main Street, Larbert Burns Avenue, Falkirk Wheel and Menstrie, Holbourne Place clockwise from the upper left.

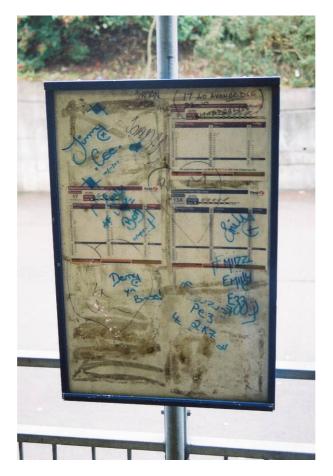
Figure K: Graffiti Covered First Timetable Case at Falkirk Bus Station

- 3.8.4 In Falkirk Bus Station, timetable cases appear to be provided by First to its own format, which includes line maps. The example shown in Figure K below has been burned and covered in graffiti. The graffiti includes notice in black marker (top right) that the 1740 and 2310 to Avonbridge are withdrawn in what appears to be semi official operator graffiti.

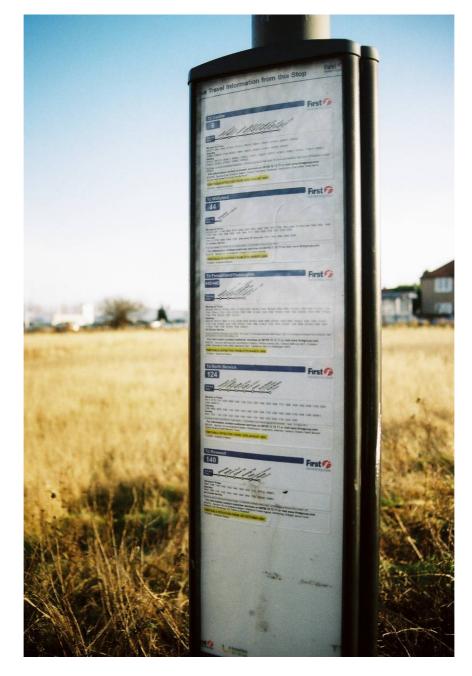
Figure M: First Edinburgh 'Full Display' – Wallyford Station

3.9.3 First Edinburgh uses the OmniStop package to produce its own in house timetable displays for its services. This allows various output formats and the main two types which it uses are shown in Figure M and Figure N. Figure M at Wallyford Station shows the full panel version with line diagrams and separate panels for each service. All text is in dark blue or black. Figure N shows the less satisfactory version laminated onto a bus shelter at Fort Kinnaird. Not only is the initial impression one of much wasted white space, but some departure times are in coloured text (explained in the coloured boxes at the foot of the display). These coloured times have faded to the point of becoming illegible.

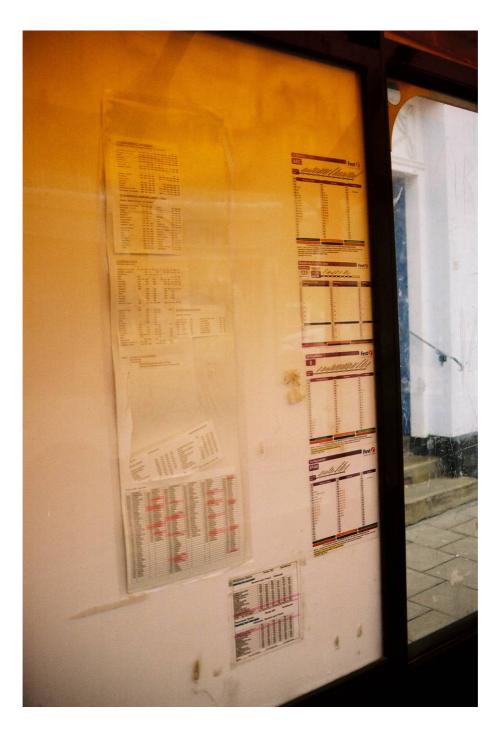
Figure O: Timetable case in Haddington

- 3.9.4 The policy of operators providing and / or inserting their own timetable information produces juxtaposed styles and formats. Figure O shows a stop in Haddington High Street in East Lothian including timetables supplied by several operators with various markings. In Prestonpans, both Lothian Buses and First Edinburgh provide services, and Figure P shows timetable displays for both these operators. The timetable for First's principal route, 129, has slipped and is now on its side. Figure Q shows a Midlothian example at Penicuik with services of Lothian, First and MacEwan's.
- 3.9.5 East Lothian produces its own timetable cases across its area, as shown in Figure R. The timetable for service 120 is the EVE Coaches' standard timetable for their services, a small amount of information for such a large display.

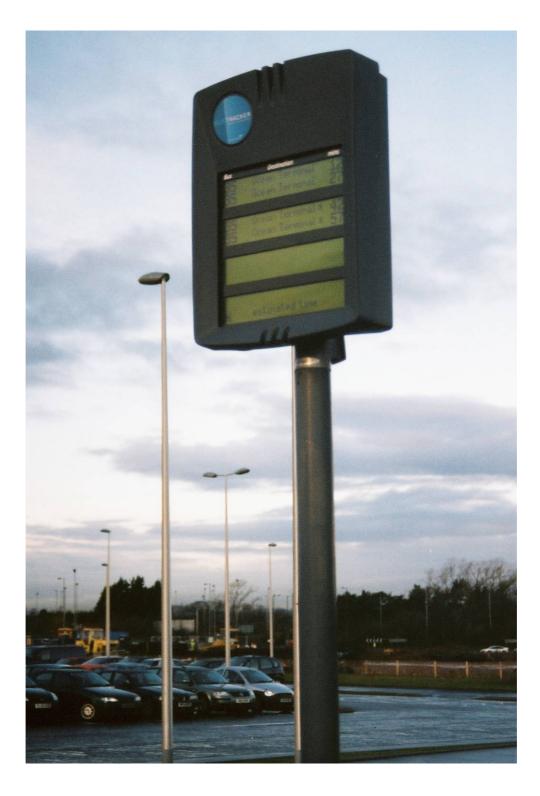
Figure S: Bus Tracker display used in Edinburgh

- 3.9.6 There are some developments in real time information provision and electronic displays. Figure S depicts a Bus Tracker display at Ingliston Park & Ride. These displays can also be found at several points in Edinburgh City Centre in addition to the park and ride sites.
- 3.9.7 As part of the redevelopment of St Andrew Square bus station in Edinburgh it also received electronic information displays, in addition to the timetable cases electronic displays as shown in Figure T clearly show the time of the next bus departure, the service number and destination and the operator of the service.

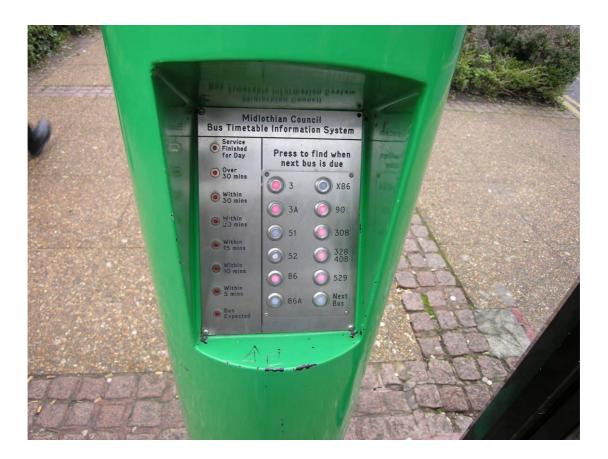
Figure U: Midlothian Council information display in Dalkeith

3.9.8 Midlothian Council has installed some information points such as in that in Dalkeith which provides timetable information. An example of one of these displays, at Buccleuch Street can be seen in Figure U. This particular display was out of action at the time of our surveyor's visit.

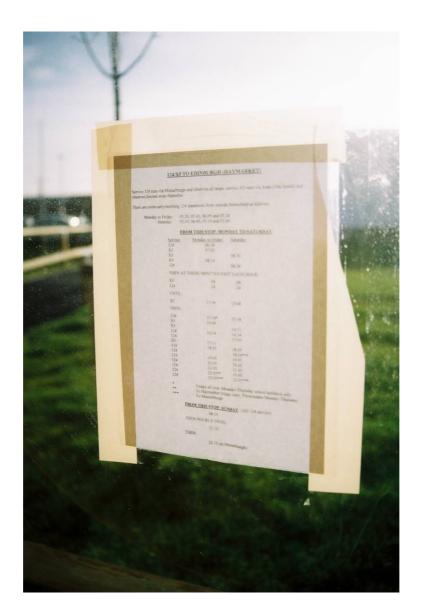
Figure V: Makeshift Timetable Display at North Berwick, Tesco

3.9.9 In January, the bus stop at Tesco did not have a timetable case, but did have a makeshift timetable display taped to the shelter, as shown in Figure V.

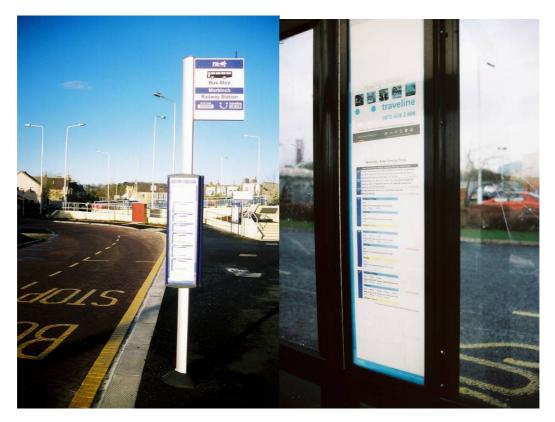
Figure W: Examples of Named Bus Stop and Fife Standard Information Displays at Markinch Station and Kirkcaldy ASDA

3.10.1 Fife, as already noted, has a high standard of information presentation, although not all of Fife's bus stops have received the updated Traveline number. Figure W below at Markinch Station and Kirkcaldy ASDA illustrate standard Fife council stops with stop and service specific information, although the latter still shows the obsolete Traveline number. Each service using the stop has its own timetable panel and the stop is well located immediately outside the station entrance.

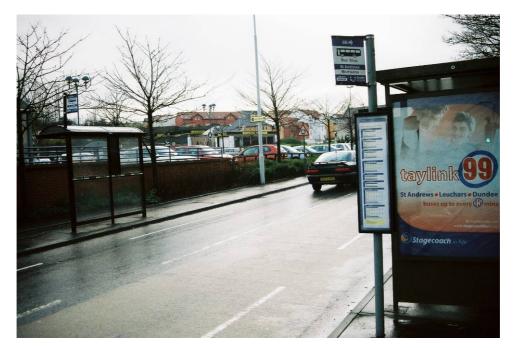
Figure Z: Promotion of Upgraded Service 99 in St Andrews

- 3.10.4 External advertising of specific conventional bus routes is unusual in the UK except in the form of branding on buses themselves. It is encouraging to see, therefore, that as part of the route 99 relaunch in St Andrews, Stagecoach has undertaken a promotional campaign to attract more users to the bus including the taking up of advertising space at bus stops. An example of this publicity can be found in Figure Z.

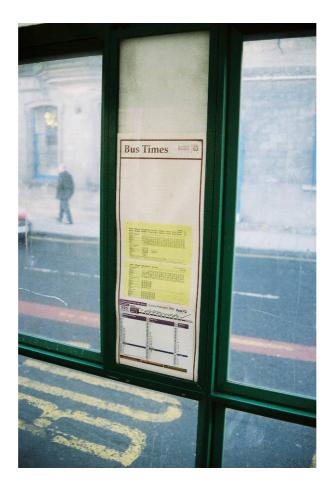
Figure AA: Scottish Borders Council Timetable Case at Hawick

3.11.1 The Borders area produces a multiplicity of timetable formats and sizes. An example of Scottish Borders timetable case inserts can be found in Figure AA below. This was taken at Hawick and shows First Edinburgh X95 and Munro's Hawick town services. Note how the full timetable is shown for the town services while only departure times are shown for the long X95 to Edinburgh. No information is included for First's local services. Figure BB also shows First announcing route alterations in Hawick using a notice attached to the shelter at Hawick, Morrison's.

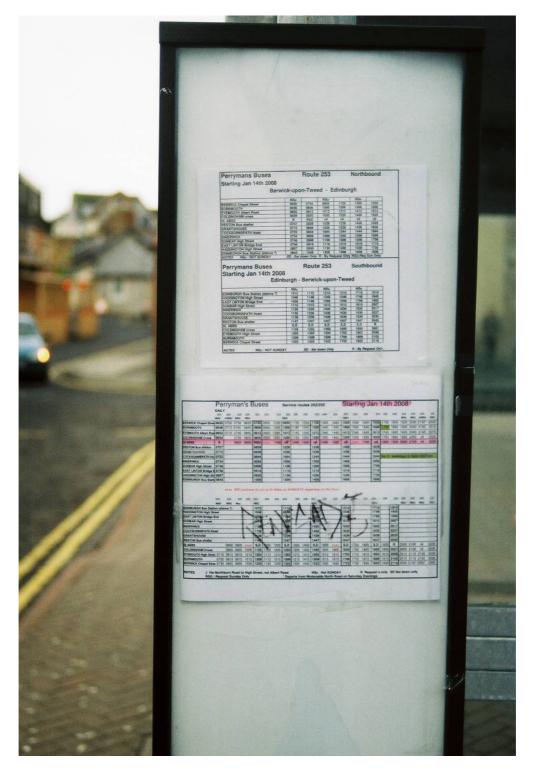
Figure CC: Perryman's Timetables at Eyemouth

3.11.2 The independent operators in the Scottish Borders seem to make reasonable attempts to install and maintain information displays. Perryman's Buses has a small network of services around Eyemouth and Berwick upon Tweed. Figure CC was taken at Eyemouth showing the timetable case there. Eyemouth is also served by Travelsure on the service to Duns, although no information was included in this timetable case. An example of Munro's timetables can be found in Figure DD. Figure EE shows a timetable case at Borders General Hospital including consolidated information for all services and operators, which has information around 18 months out of date old at time of observation.

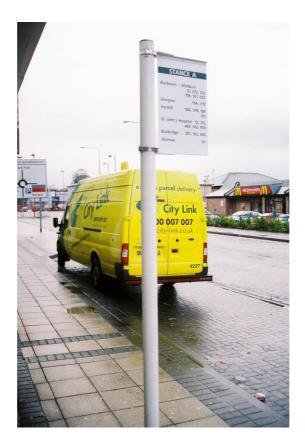
Figure FF: Bus Stop Flag at Livingston Showing Service Information

- 3.12.1 West Lothian Council prepares its own timetable information. Some West Lothian bus stop flags include destination information
- 3.12.2 Figure FF below shows an example where this information appears on a stop flag, at Livingston Bus Terminal. Route specific information is also used in West Lothian, detailing departures by operator throughout the day. Figure GG demonstrates the comprehensiveness of these displays at Armadale Cross. However, with such a long list of departures it brings into question whether the average passenger will find the required information within the 'eight second rule'.
- 3.12.3 Livingston Bus Terminal also has computerised information displays advising users of bus times. These information screens are additionally located at St Johns Hospital, as shown in Figure HH and Figure II.

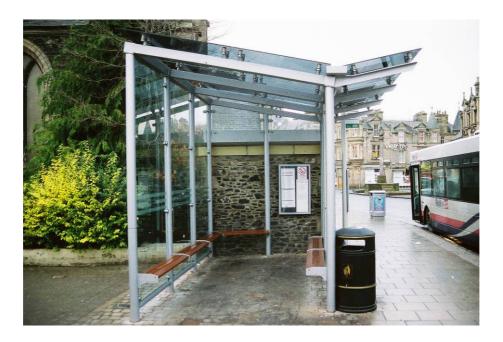
Figure JJ: Bus Shelter in Peebles

4.4.1 Scottish Borders Council has been investing in new bus shelters, and Figure JJ shows the one in Peebles. This has been in place since at least 2005 and is in very good condition.

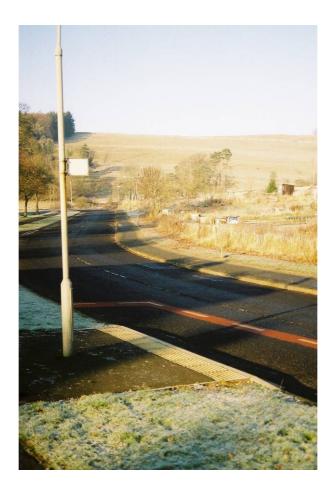
Figure KK: Bus stop at Hawick Stirches

4.4.2 Scottish Borders Council has also been updating existing infrastructure, as shown by this stop with raised kerbing in Hawick.

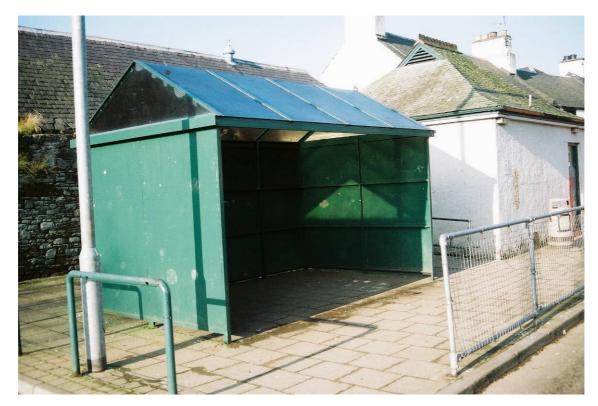
Figure LL: Bus Shelter in Earlston

4.4.3 Some existing shelters remain within the Borders area, as shown Figure LL by taken in Earlston in February. This shelter was in a poor condition with evidence of vandalism and no timetable information.

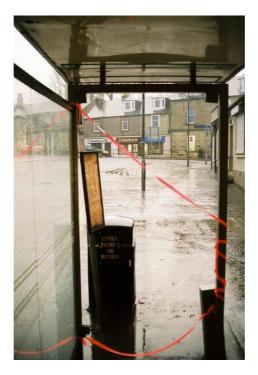
Figure MM: Bus shelter in Bonnybridge

4.4.4 Some shelters in the Falkirk council area are in a poor condition and in need of replacement, as shown by Figure MM taken in Bonnybridge during December 2007.

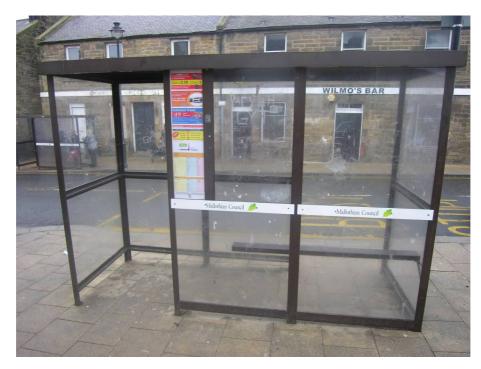
Figure NN: Midlothian Council shelter in Gorebridge

4.4.5 In many cases, where new shelters are installed by councils, these are identified by the relevant council logo on the shelter, as shown by Figure NN which was taken in Gorebridge.

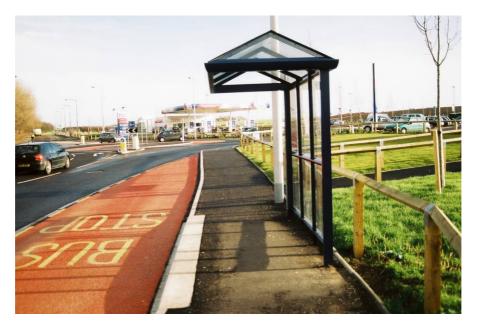
Figure PP: Bus shelter at North Berwick, Tesco store

4.4.7 Figure PP below shows the bus shelter at North Berwick, Tesco with raised kerbing. This was the stop with makeshift timetable display referred to earlier.

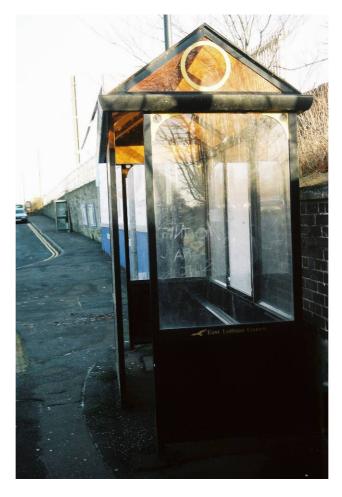
Figure QQ: East Lothian council shelter at Longniddry

4.4.8 A standard design East Lothian council shelter, taken at Longniddry station in January is depicted in Figure QQ.

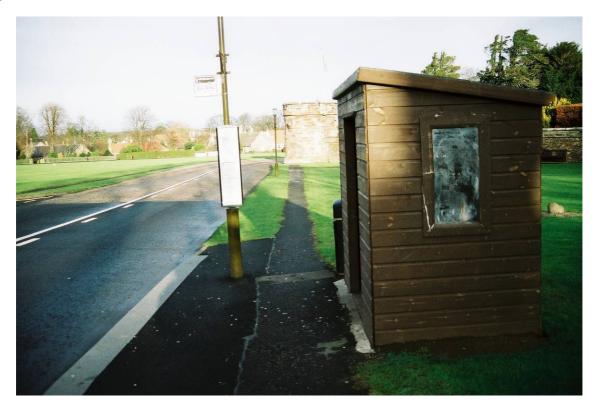
Figure RR: Timber bus shelter at Dirleton

4.4.9 This timber framed shelter (Figure RR) was photographed in Dirleton in January. The village is served by two First Edinburgh routes to North Berwick. Some vandalism is evident on the plastic screens.

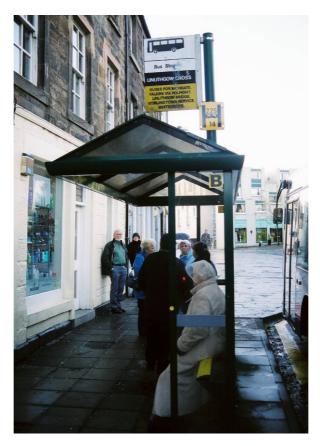
Figure TT: Bus shelter in Linlithgow

4.4.11 Figure TT shows a shelter in Linlithgow, West Lothian which is insufficient for the numbers using services through the town.

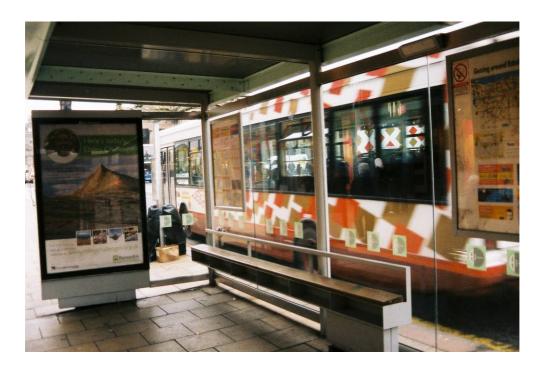
Figure WW: Inside of Bus shelter on Princes Street in Edinburgh

4.4.14 Bus shelters on Princes Street in Edinburgh are finished to a high standard, as shown in Figure WW.

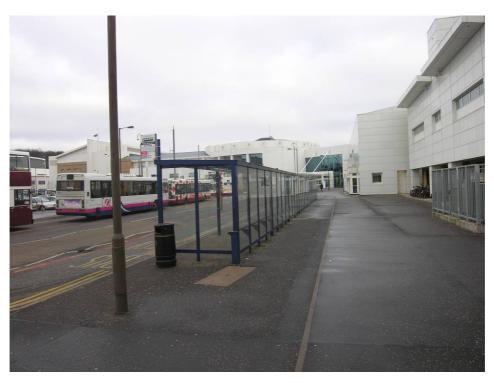
Figure XX: Bus shelter at Edinburgh Royal Infirmary

4.4.15 At some locations in the SEStran area, larger shelters are required due to the high volumes of passengers using some stops. One such example is at Edinburgh Royal Infirmary, as shown below in Figure XX.

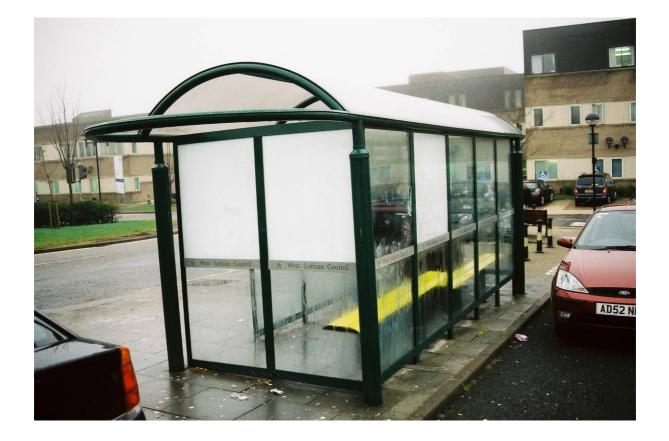
Figure YY: West Lothian Council bus shelter in Livingston

4.4.16 The shelter shown below, in Figure YY was taken at St John's Hospital in Livingston. In addition to a new shelter, an electronic information system is in place, similar to that used at the bus terminal in Livingston.

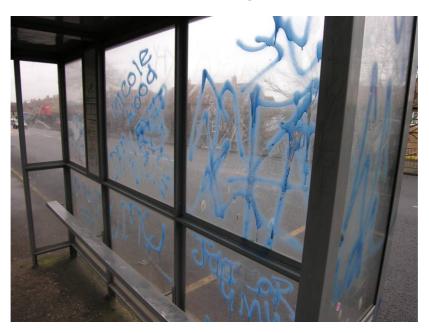
Figure AAA: Bus Shelter at Dalkeith, Hepburn Drive

4.4.18 Some shelters in Midlothian have unfortunately suffered at the hands of vandals, as shown below in Figure AAA.

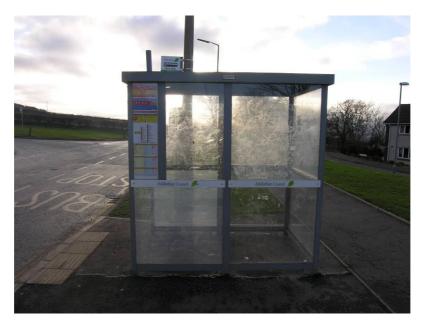
4.4.20 shows a vandalised (severely etched) stop in Mayfield which also has timetable information on the outside of the shelter, as opposed to inside.

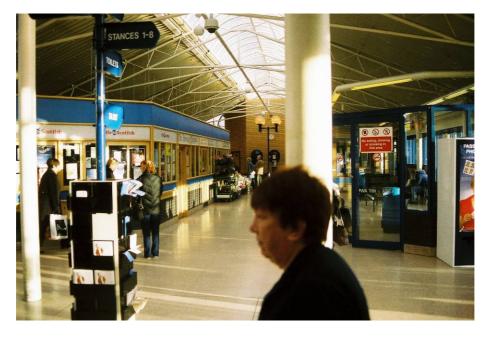
Figure DDD: Main Bus Station building, Glenrothes

5.1.4 The main building at Glenrothes was opened in 1991 and remains in extremely good condition. Figure DDD below shows the inside of the main building, whilst Figure EEE shows the stances.

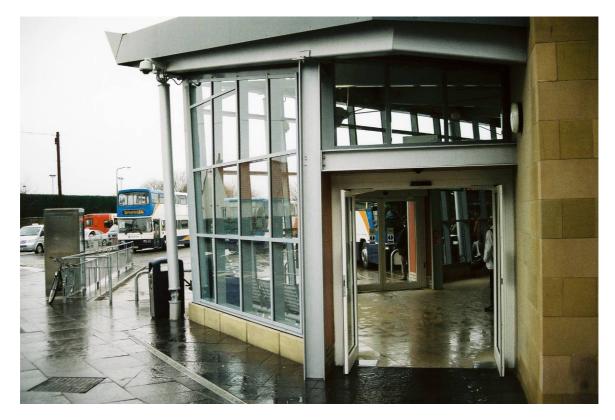
Figure FFF: Main building, St Andrews Bus Station

5.1.5 Figure FFF below shows the main building at St Andrews Bus Station. What is not readily apparent from the photo is the fact that the bus station has insufficient stand space for the buses using it, which leads to congestion where additional buses require the bus bays.

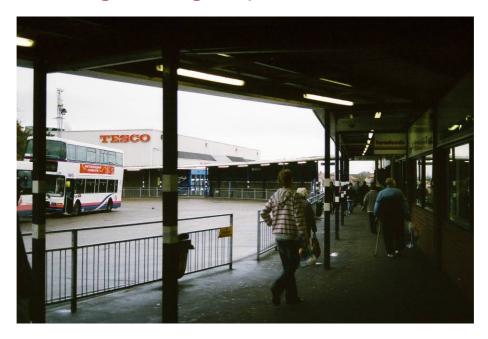
Figure GGG: Passenger waiting area, Falkirk Bus Station

5.1.6 Falkirk Bus Station is owned by First Edinburgh and is one of a few sites owned by operators. Other operators of secured services pay departure charges to First for its use. As can be seen from Figure GGG and Figure HHH, the bus station is in need of refurbishment and upgrade to a higher standard than is currently the case.

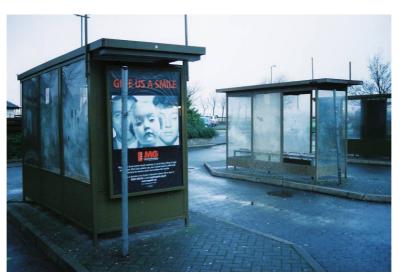
Figure III: Bo'ness Bus Station shelters

5.1.7 Bo'ness Bus Station has been badly vandalised, as shown by Figure III which was taken in December 2007. In addition to this, Figure JJJ shows the entrance road means bus steps are raised at the shelters, making entry onto and exit off the bus more difficult. No raised kerbs are in place here to allow customers to maximise the benefits of First Edinburgh's investment in accessible vehicles.

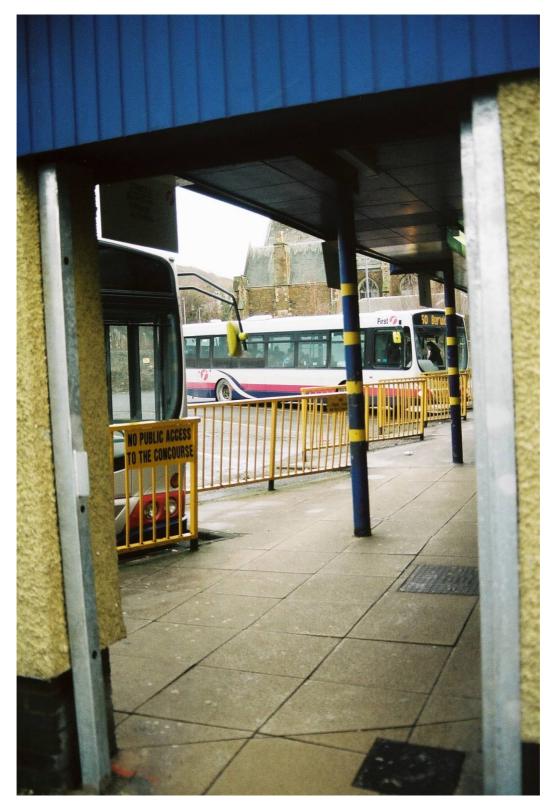
Figure KKK: Galashiels Bus Station

5.1.8 Galashiels Bus Station, in the Borders is much better presented than Falkirk or Bo'ness. A general impression of the stands can be gained from Figure KKK.

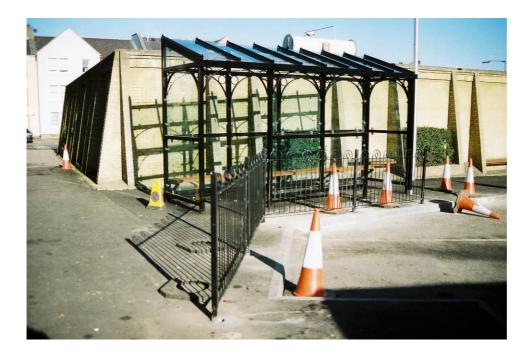
Figure MMM: Jedburgh Bus Station railings

5.1.9 Figure MMM shows the railings being installed in February.
